4. LONG ISLAND CITY RESPONSE

4.1. Response to Primary Feeder Outages

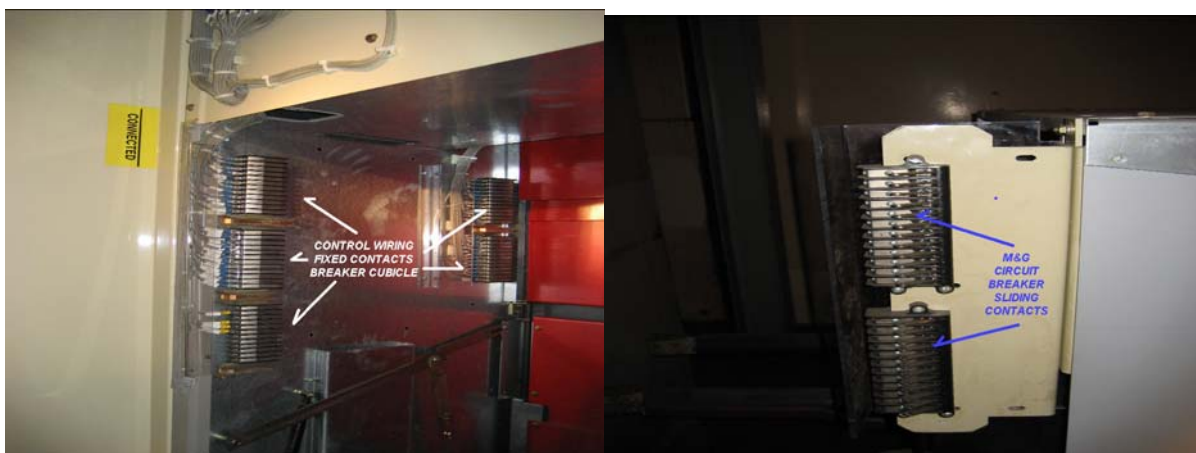
Figure 4-2: Photograph of sliding contacts

Both 34W and 34E are retrofitted Merlin Gerin Model SF2 rack-out breakers. A rack-out breaker can be removed from a breaker cubicle. Rack-out breakers require control-wiring contacts to provide, for example, breaker position indication, and close and trip coil connections. Stationary contacts in the breaker cubicle mate with contacts on the moveable breaker making up the control and indicating circuits and allowing for proper breaker operation.

Breakers 34W and 34E did not operate properly because, for each breaker, one of the 24 contacts was not making contact between the fixed and movable control wiring contacts. See Figure 4-2. The failure of 34W to open when feeder 1Q21 faulted, resulted in the backup overcurrent relay tripping the entire bus section 3S.

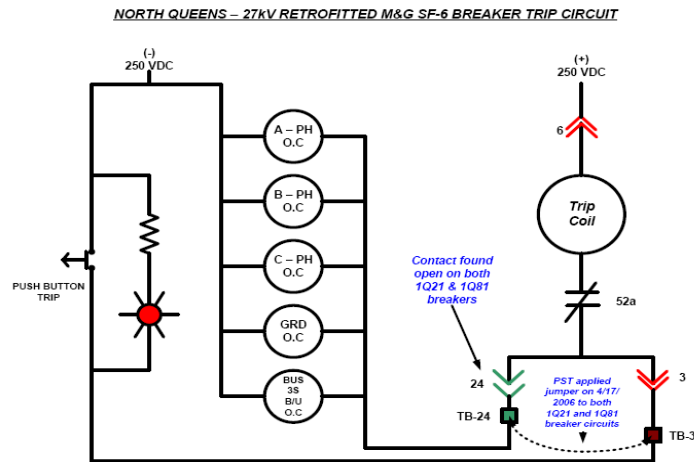
Figure 4-3: Simplified Schematic of 27kV Retrofitted M&G SF-6 Breaker Trip Circuit

During the restoration of bus section 3S, one feeder (1Q15) was successfully restored, reducing the network contingency level to four (feeder 1Q07 opened auto on the cut in due to a feeder fault). At this time, crews tested the trip circuit ladder and found that on both 1Q21 and 1Q81, the relay-protection trip path was open while the supervisory trip path and its associated indicating light were fully functional. Upon further investigation, technicians found that for each of these breakers, the movable contact (Terminal 24) was not making contact between the fixed and movable control wiring contacts. This resulted in the relay protection trip path becoming inoperable, causing both 34W and 34E not to open on a relay operation. A temporary jumper was immediately installed between the relay protection path (terminal 24) and the supervisory trip path (terminal 3) to allow the relay and supervisory trip signals to reach the breaker trip coil via parallel paths. See Figure 4-3. After applying the temporary jumper, a modified trip check was performed to verify that if there were a future event, breakers 34W and 34E would trip via protective relays. Circuit breakers are normally provided with a trip circuit monitoring scheme that provides both a visible and audible indication of a lack of continuity in its associated trip circuit. The original breakers installed in the North Queens substation had a trip circuit monitoring indication light without an audible alarm. This monitoring light is located in the substation control room and serves two purposes: visual indication that the breaker is closed, and visual indication that the relay and remote supervisory paths are being monitored. The loss of this indication light would mean that either the relay trip path or the remote supervisory path was interrupted.

The North Queens retrofitted breakers have the control room indication light discussed above and an additional indication light attached to each breaker cubicle. The loss of this additional breaker indication light would mean that either the trip coil or the breaker push button trip circuit is defective (i.e., local supervisory trip circuit). Therefore, the retrofitted breakers have an indication light in the control room as well as at the breaker control box.

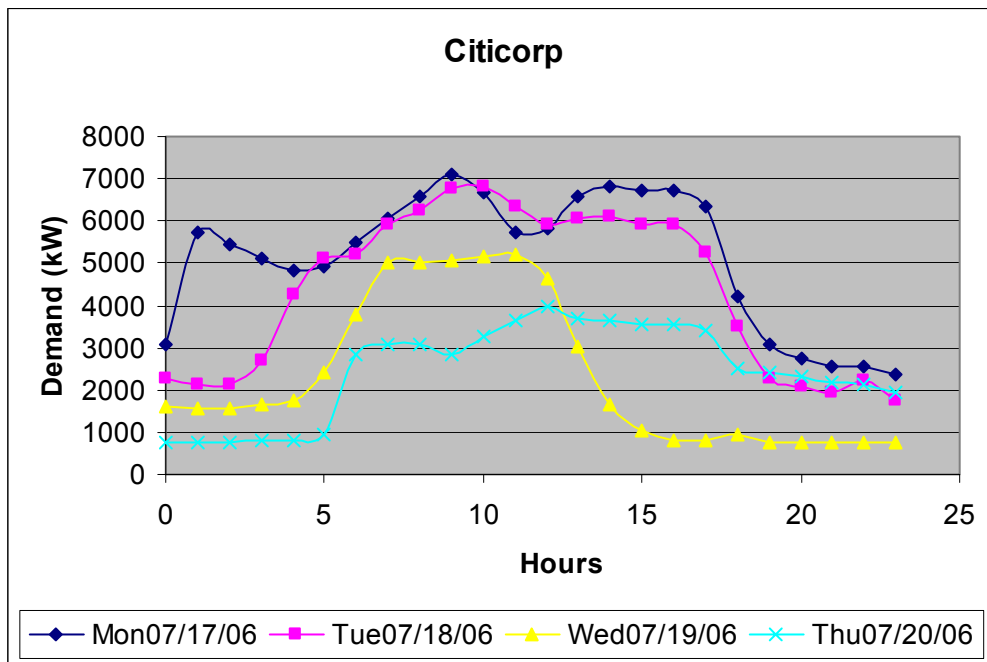
Figure 4-7: Citicorp Daily Electric Demand

On Wednesday, July 19, calls were made to specific customers requesting that they curtail operations and take steps to eliminate all electricity use. Customers responded by halting industrial operations and shortening office hours. In addition, Citicorp and MetLife decided to shut down on portions of Wednesday. Figure 4-7 displays the response of Citicorp on Wednesday, July 19, and Thursday, July 20, relative to Monday, July 17, and Tuesday, July 18.

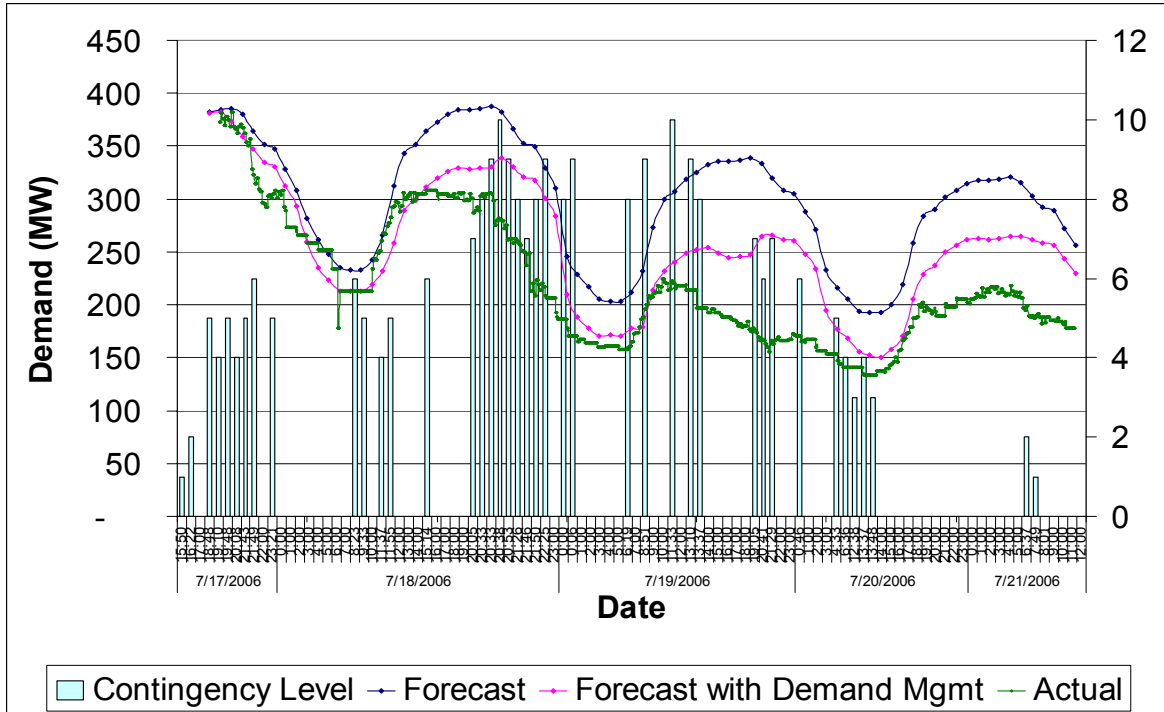
Figure 4-8: Forecasted Electric Demand in LIC Network versus Actual Demand

Based on subsequent analysis, this demand reduction, especially during Wednesday, July 19, was not enough to explain the reduction in electric system usage. As part of Con Edison's further investigation, the company has attempted to estimate the forecasted load and reduced forecasted load from Monday, July 17 to Thursday, July 20, to better review the company's demand response. This is shown in Figure 4-8.

The area between the “Forecast with Demand Management” curve and the “Actual” curve is unaccounted for demand reduction that in retrospect, was likely due to a combination of voluntary load reduction by small commercial and residential customers (which Con Edison was unable to quantify), and customer outages, (which Con Edison was also unable to quantify). Table 4-10 shows the percentage difference between the average actual load and the average forecast with demand reduction, as well as the number of customer outages that would account for that difference if it is assumed that 100% of the difference was due to customer outages.⁴

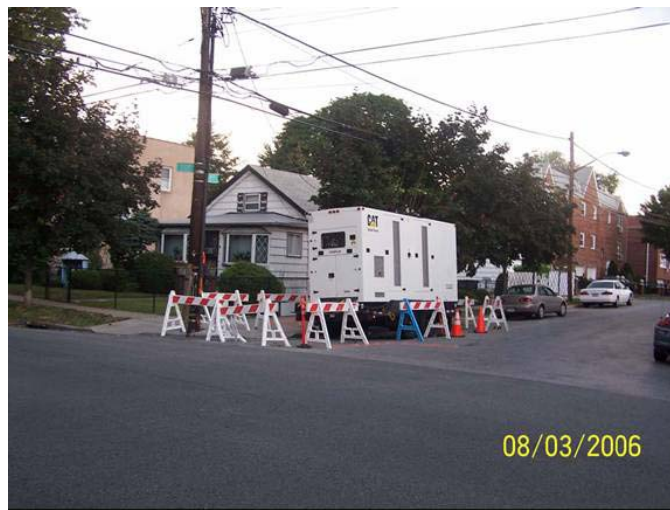
Figure 4-10: Mobile Generator Set Up in LIC

safeguarding the general public at each location. Security Services and personnel from the Facilities Group performed spot inspections on the security guards at the generator sites. In addition, the generators themselves were surrounded with barricades and tape, and high voltage signs were displayed as visual cues reminding the public to remain at a safe distance. Figure 4-10 shows these precautions.
